**Flood Control Project Maintenance
Levee Inspections**
LMA District Cover Sheet
Spring 2017 Levee Inspection Results

Sacramento Maintenance Yard East Levee Yolo Bypass

Levee Inspection Report By Mile - Spring 2017

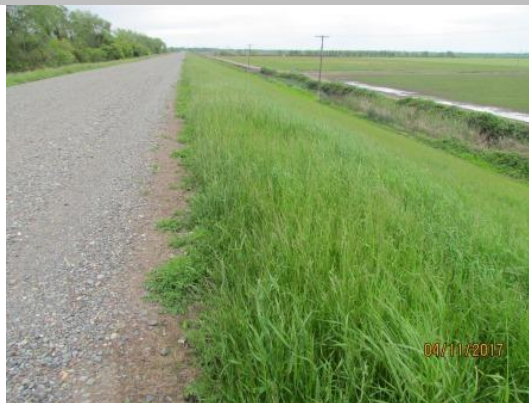
Photo 1 of 1 : SP_2017_ST0004_41_7_20170413_00006.jpg

LM Start	0.00	Rating **	M	Issue No.	7
LM End	2.01	Issue Type +	Ma	Location *	LS
Category	Earthen Levee			GPS Latitude/Longitude	
				Start	End
Item	Vegetation			38.765342 °	38.736315 °
				-121.635056 °	-121.633680 °
DWR ID	DWR_ST0004_01_s_2017_7				
Comment Code					
V1 : Control annual grass and weeds on the levee slopes and easements.					
Inspector Comment

Tall grass on landside levee slope, blocking visibility. Spring 2017.

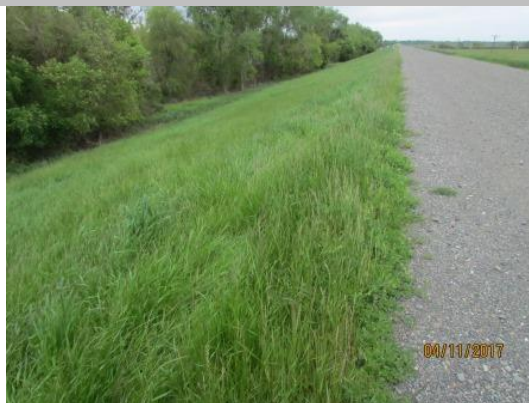
Photo 1 of 1 : SP_2017_ST0004_41_8_20170413_00007.jpg

LM Start	0.09	Rating **	M	Issue No.	8
LM End	1.64	Issue Type +	Ma	Location *	WS
Category	Earthen Levee			GPS Latitude/Longitude	
				Start	End
Item	Vegetation			38.764109 °	38.741661 °
				-121.635551 °	-121.634064 °
DWR ID	DWR_ST0004_01_s_2017_8				
Comment Code					
V1 : Control annual grass and weeds on the levee slopes and easements.					
Inspector Comment

Tall grass on waterside levee slope, blocking visibility. Spring 2017.

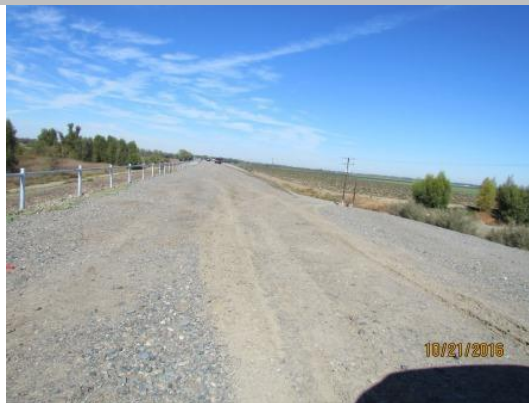
Photo 1 of 1 : SP_2017_ST0004_41_2_20170320_00003.jpg

LM Start	1.21	Rating **	M	Issue No.	2
LM End	1.21	Issue Type +	Ma	Location *	CR
Category	Earthen Levee			GPS Latitude/Longitude	
				Start	End
Item	Crown Surface / Depressions / Rutting			38.747823 °	38.747823 °
				-121.634418 °	-121.634418 °
DWR ID	DWR_ST0004_01_f_2016_2				
Comment Code					
C2 : Repair depressions or ruts in the crown or slope.					
Inspector Comment

Ruts on levee crown. Fall 2016.

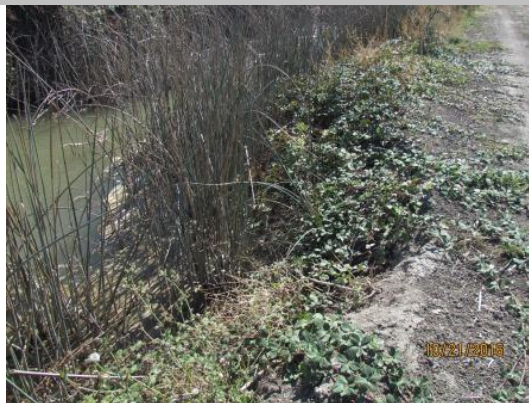
Photo 1 of 2 : SP_2017_ST0004_41_1_20170320_00001.jpg

LM Start	1.51	Rating **	M	Issue No.	1
LM End	1.51	Issue Type +	Ob	Location *	LS
Category	Earthen Levee			GPS Latitude/Longitude	
				Start	End
Item	Erosion / Bank Caving			38.743573 °	38.743573 °
				-121.634128 °	-121.634128 °
DWR ID	DWR_ST0004_01_f_2016_1				
Comment Code					
E1 : Note and monitor erosion site.					
Inspector Comment					
Erosion on a side of a ditch toward LS toe caused by water coming out of irrigation canal.

Irrigation ditch erosion on landward side toward LS levee toe. Fall 2016.

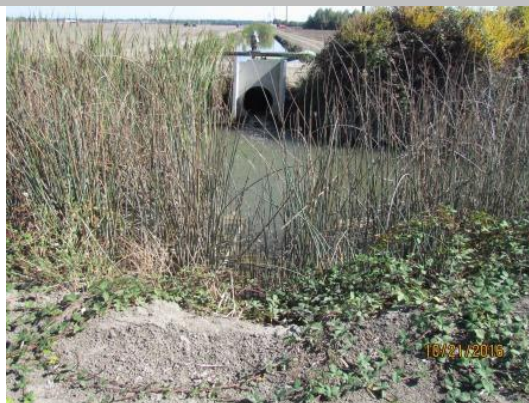
Photo 2 of 2 : SP_2017_ST0004_41_1_20170320_00002.jpg

LM Start	1.51	Rating **	M	Issue No.	1 (cont)
LM End	1.51	Issue Type +	Ob	Location *	LS

Irrigation ditch erosion caused by water flowing from perpendicular irrigation canal. Fall 2016.
